Challenges and solutions in PGM furnace operation: high matte temperature and copper cooler corrosion

by A. Shaw*, L.P.v.S. de Villiers†, R.J. Hundermark†, J. Ndlovu†, L.R. Nelson†, B. Pieterse†, R. Sullivan*, N. Voermann*, C. Walker*, F. Stober*, and A.D. McKenzie‡

Synopsis

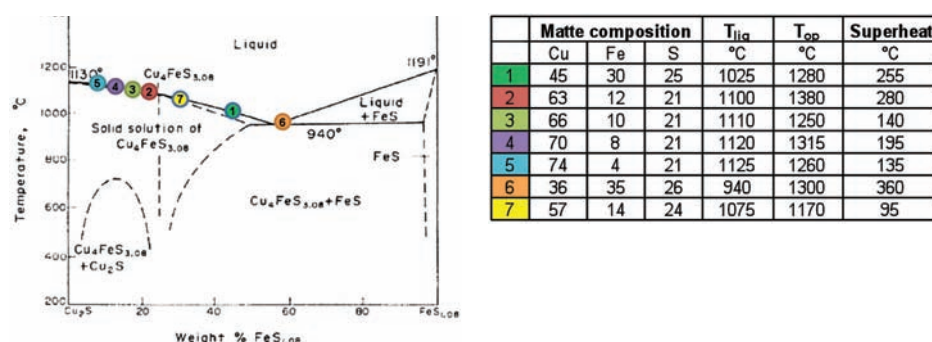
Figure 1—Copper primary matte liquidus temperatures (diagram after Schlegel and Schüller, 1952; matte composition information after Kapusta, 2004)

When one considers the copper matte formed in these furnaces, the matte liquidus temperatures range from around 940°C to around 1125°C, and a maximum difference of 360°C between the operating temperature and the matte liquidus temperature is observed (Figure 1).

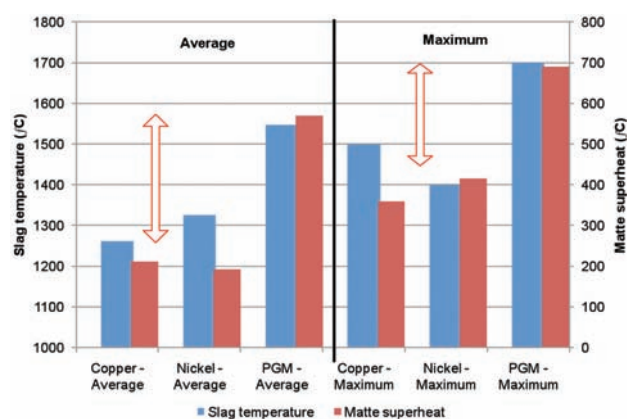
Figure 2—Comparison of operating temperatures and matte superheats across the copper, nickel, and PGM smelting industries

The average and maximum slag temperatures and matte superheats in the primary furnaces of the copper, nickel, and PGM smelting industries were calculated based on the information available in the aforementioned reviews and are shown in Figure 2. The step change increases in slag, and therefore operating, temperatures and most significantly matte superheats are evident for the PGM industry.

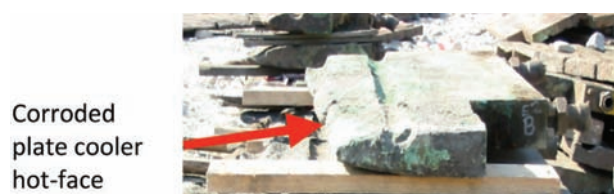
Figure 4—Severe upper plate cooler corrosion at Waterval Smelter. Note increased corrosion of upper plate cooler located in the furnace nearest the top of slag and concentrate interface

Corrosion is also not limited to waffle coolers. Given time, copper plate coolers in PGM furnaces are corroded to a short sharp edge (Figure 4), barely protruding into the furnace wall, and so reducing their cooling effect and upper wall stability. The corrosion is pervasive and continues to some extent throughout the furnace, not being limited to attack of copper, but also of basic magnesia-based refractories where magnesium sulphates (often resulting from sulphidation of

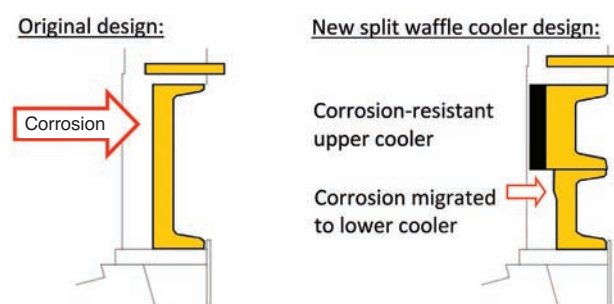
Figure 5—Initial copper loss in slag-concentrate interface zone. Following splitting of the coolers and protecting the upper block, copper corrosion migrated to the unprotected lower block

As part of the comprehensive plan to address corrosion, which is described later, the coolers were split horizontally into upper and lower blocks. After an effective corrosion-resistant barrier was applied to the hot face of the upper waffle coolers, the corrosion problem on these blocks significantly abated; however, the corrosion migrated to the 'deliberately' unprotected lower waffle coolers (Figure 5), though at a reduced rate.

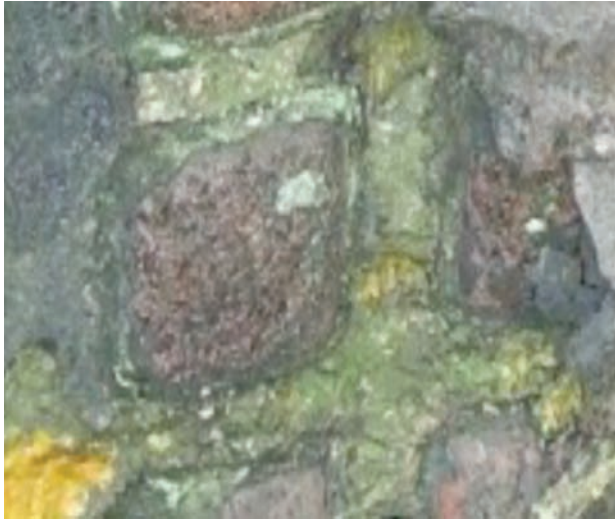
Figure 6—Typical corroded cooler – yellow elemental sulphur deposited on black copper sulfide corrosion product on copper. Grey covering is frozen slag accretion

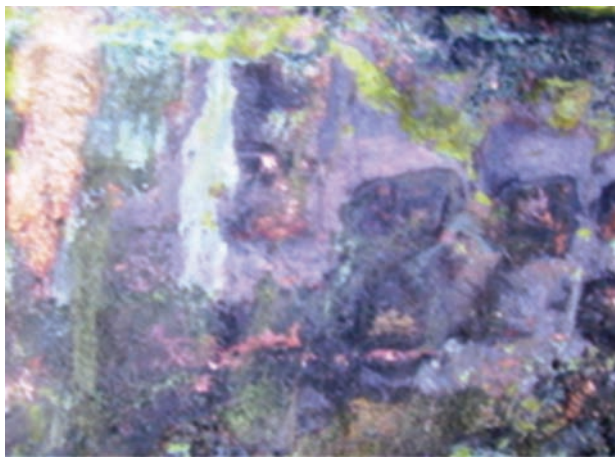
Figure 7—Severely corroded, unprotected copper block. Black copper sulphide pervasive. Increasing evidence of green copper hydroxy-chloride in close proximity to copper

In an attempt to simulate the presence of the thin copper chloride layer observed on most operational coolers (e.g., failed unprotected lower waffle cooler – Figure 7) a test was devised where the copper was first subjected to 1 day of exposure to 5 per cent HCl(g) by volume, followed by standard sulphidation with sulphur vapour. At a temperature of 90°C, after the initial exposure to HCl for 1 day, corrosion was not measurable.

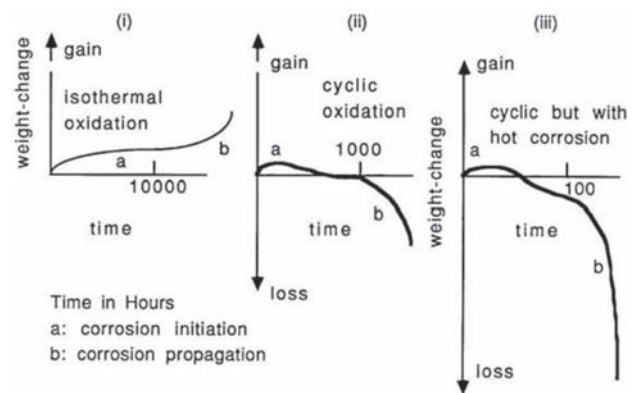
Figure 14—Corrosion mode typical of hot corrosion systems (after Hocking *et al.*, 1989)

The rate of 'hot corrosion' (by definition, corrosion in the presence of sulphur species) is inherently highly non-linear with respect to time (Figure 14). Coupled with the specific cooler conditions described above, this will further contribute

to a greatly accelerated rate of copper wear with cooler operating time. This is consistent with the great difficulty experienced in attempting to use condition-monitoring of copper thickness to predict the timing for safe replacement of the coolers before failure. In one instance of lower waffle cooler failure, involving detection through the automated water-pressure leak detection system of cooler water leaks into the Polokwane furnace, the mean rate of copper wear in front of the cast monel water pipes increased by over an order of magnitude in under a year, from 1.4 mm/a to 40.3 mm/a.

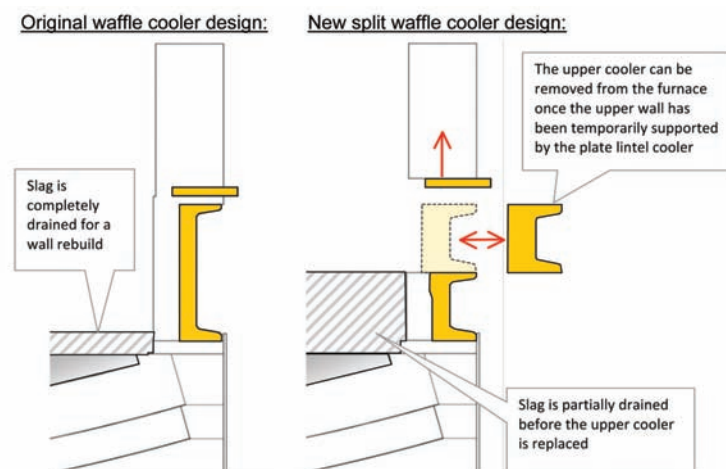
Figure 17—Diagram showing the original waffle coolers and the redesigned split coolers, which can be replaced quickly from outside a 'hot' furnace

It was possible to reduce the replacement cost of the waffle coolers by splitting them horizontally into upper and lower blocks because the most severe corrosion occurred mainly in the upper portion of the waffle coolers near the slag-concentrate interface (Figure 17). By doing this, the corrosion-prone upper waffle coolers could be replaced independently of the lower waffle coolers. One advantage of this arrangement is that the slag bath needs to be only

partially drained to replace the upper waffle coolers. Partially draining the furnace can be done using only the slag tapholes, instead of the more complicated and time-consuming exercise of draining the remaining portion of slag bath through the matte tapholes into the matte tapping aisle.

With the original full-height waffle coolers, a complete sidewall rebuild could take up to 6 weeks to perform, and require a cold shut-down for workers to enter the furnace for cooler removal. To reduce this time, a system was designed to remove and replace the upper row of waffle coolers from outside the hot furnace. This change enabled the upper waffle coolers to be replaced in less than 1 week. With the success and further development of the 'hot' shutdown technique, both upper and lower waffle cooler replacement is now also possible in under a fortnight.

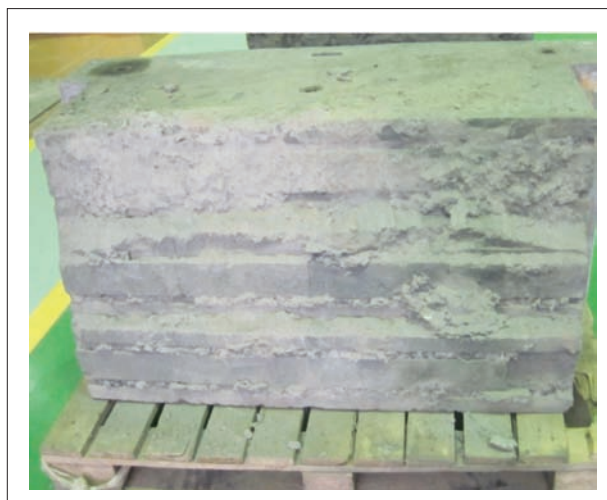
Figure 19—Perfect lower cooler graphite hot-face after being installed in the furnace for 12 months

Two consecutive planned annual inspections of the latest generation of graphite-protected copper coolers revealed the graphite to be in near pristine condition after 12 months' service. Given that the life of the original coolers was approximately one year, these results are very positive.
