# The Effect of Anisotropy on the Fatigue and Fracture of a 12 per cent Chromium Steel

M. B. CORTIE\*, C. J. FLETCHER\*, and W. VELDSMAN†

The manufacturing process for 3CR12, a dual-phase steel containing 11 per cent chromium, produces a material with a directional microstructure, a relatively well-developed crystallographic texture, and anisotropic tensile properties. This paper examines the toughness and fatigue resistance of this alloy and, in particular, the effects of its microstructure.

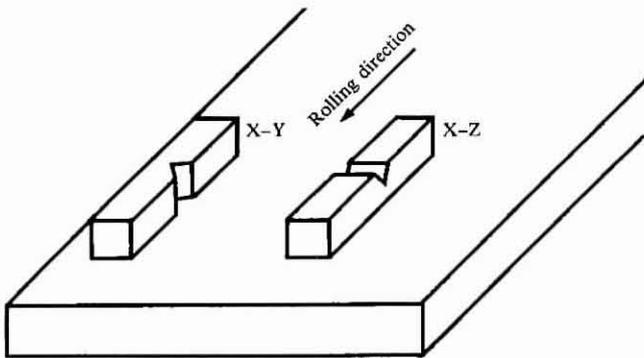
FIGURE 1. Notation used to describe the orientation of impact-toughness and compact-tension specimens (see British Standard BS 5447 for more details<sup>13</sup>)

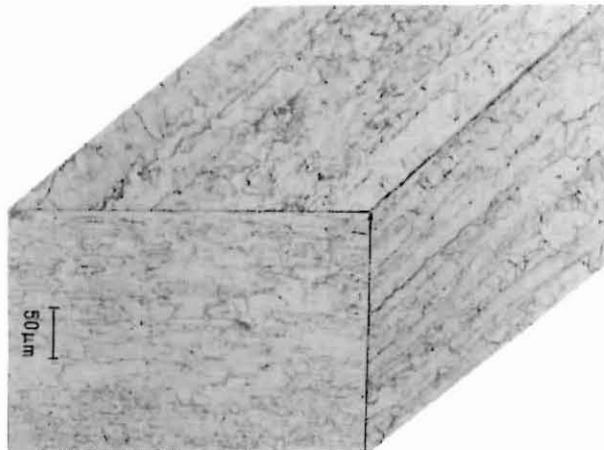
FIGURE 2. Microstructure of as-received 10 mm 3CR12 plate in transverse, longitudinal, and normal directions (micrographs assembled in a pseudo three-dimensional representation, etched in Modified Kallings solution)

The microstructure of the as-received plate is shown in Figure 2 for all three orientations. The pronounced anisotropy of the microstructure is clearly visible. Some of the fatigue-endurance specimens were heat-treated to yield a ferrite-plus-martensite microstructure. This was accomplished by immersion in a neutral salt bath at 1000 °C for 1 hour, followed by water quenching. Quantitative image analysis indicated that such specimens consisted of about 80 per cent martensite, with the balance ferrite (Figure 3).

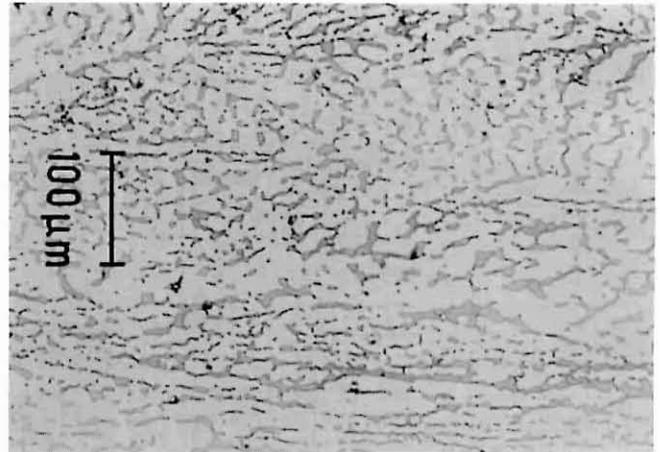
FIGURE 3. Microstructure of 25 mm 3CR12 plate quenched from 1000 °C (potentiostatically etched in sodium hydroxide)

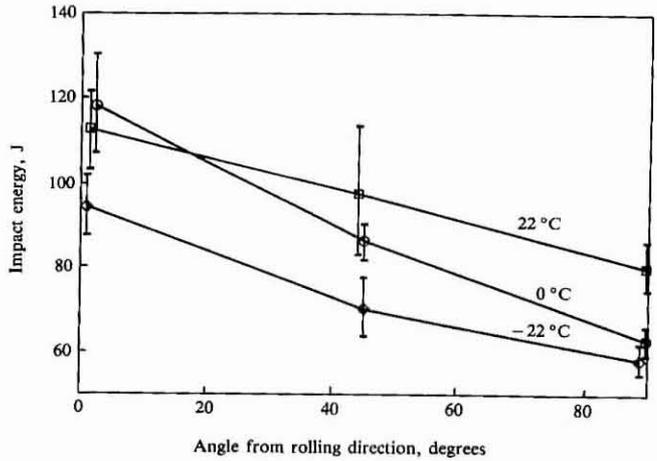
FIGURE 5. Room-temperature fracture toughness as a function of the angle between the specimens and the rolling direction in 10 mm crack-divider specimens (after Matthews, Nana, and Cortie<sup>9</sup>)

The toughness of 3CR12 plate is known to vary, like that of most other steels, with the angle of the Charpy specimen to the rolling direction. Figure 5, taken from the work of Matthews and his co-workers<sup>9</sup>, shows the toughness at room temperature of conventional crack-dividing Charpy specimens at angles of 0, 45, and 90° to the rolling direction. It can be seen that, at 22 °C, the toughness of the particular plate tested varied from 90 J in the transverse orientation to 120 J in the longitudinal orientation.

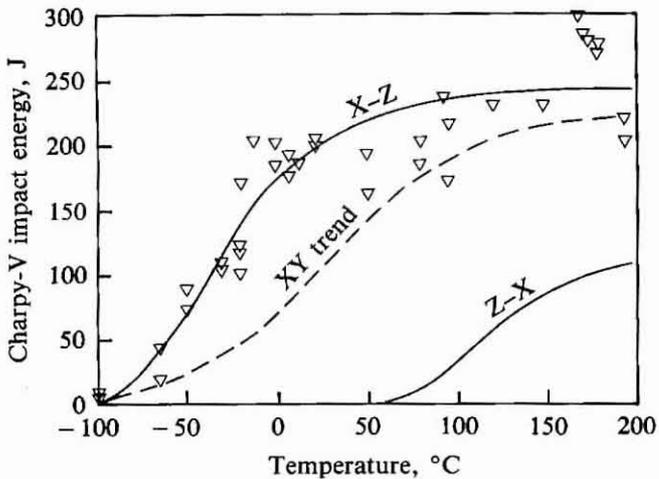
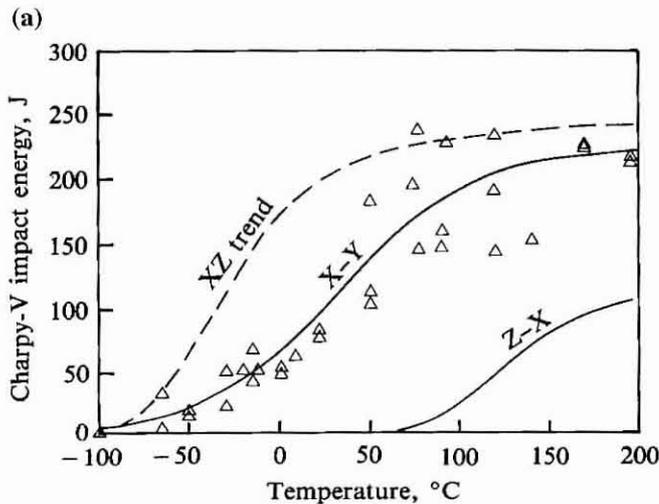
FIGURE 4. Charpy impact toughness as a function of temperature and specimen orientation for 3CR12 plates. The short-transverse line is from the work of Grobler and Van Rooyen<sup>15</sup>  
(a) crack-arrestor (X-Z) orientation  
(b) crack-divider (X-Y) orientation

Figure 4 illustrates Charpy impact energies in 3CR12 specimens as a function of temperature for longitudinally orientated crack-arrestor, Figure 4(a), and crack-divider, Figure 4(b), specimens. Also shown on Figure 4 are the

trendlines for the impact data measured by Grobler and Van Rooyen<sup>15</sup> for the short-transverse direction. It can be seen that the 150 J DBTT (a DBTT corresponding to about half the upper-shelf energy) in the crack-arrestor orientation is about  $-15^{\circ}\text{C}$ , which is considerably lower than the corresponding  $55^{\circ}\text{C}$  in the conventional crack-divider orientation. The upper-shelf energy of the crack-arrestor orientation is also somewhat higher than that of the crack-divider specimens. However, the excellent impact properties of 3CR12 in the X-Y or X-Z directions should be compared with the poor toughness of Z-X (short-transverse) specimens.

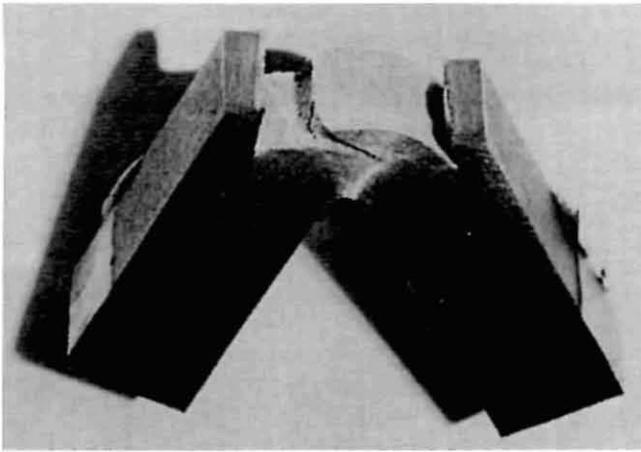
FIGURE 6. A 3CR12 Charpy specimen in the crack-arrestor orientation after impact testing

The extent of the delamination that occurs depends on the type of metal-working operation and the orientation of the material. The characteristic crack-arrestor fracture mentioned previously is obtained when the direction of crack growth within the material is perpendicular to the rolling plane (X-Z or Y-Z specimens in the notation of BS 5447<sup>13</sup>). An example of a 3CR12 Charpy specimen in the crack-arrestor orientation is shown in Figure 6. The state of triaxial stress around the tip of the advancing crack pulls the banded microstructure of the material apart, resulting in blunting of the crack, a reduction in the triaxiality of stresses at the crack tip, and a significant decrease in the DBTT.

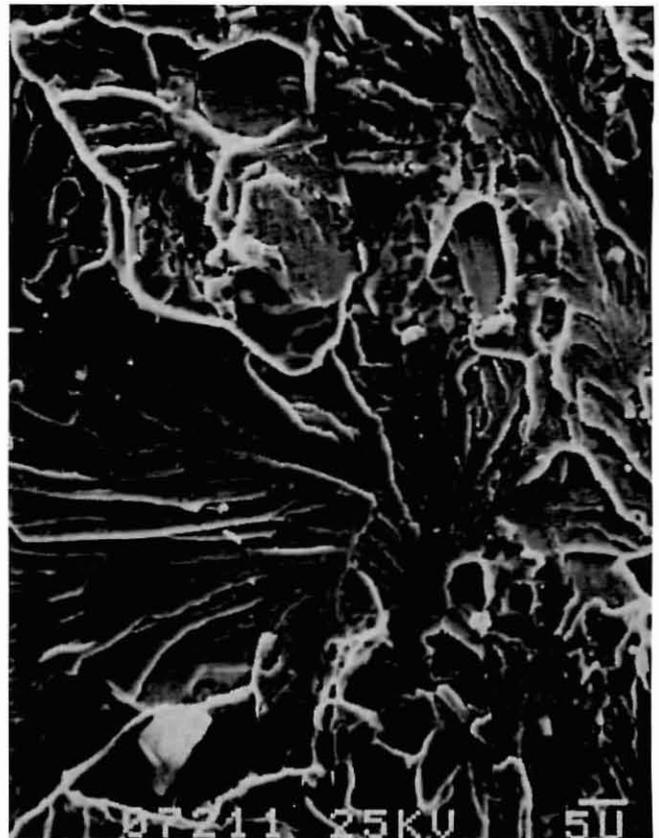
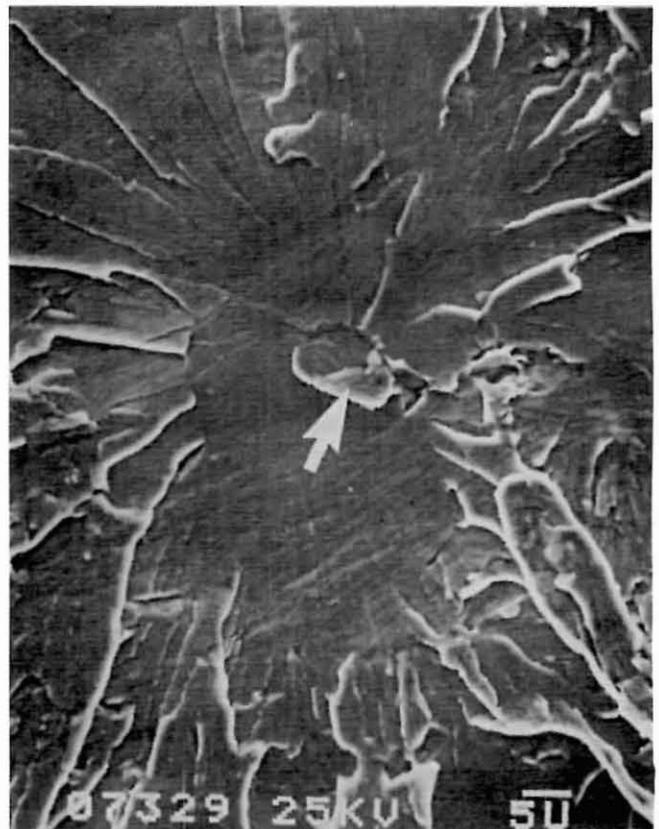
FIGURE 7. Surfaces produced by delamination (a) in a fatigue specimen with a crack growing in the short-transverse direction, and (b) in a Charpy impact test with a crack-arrestor specimen

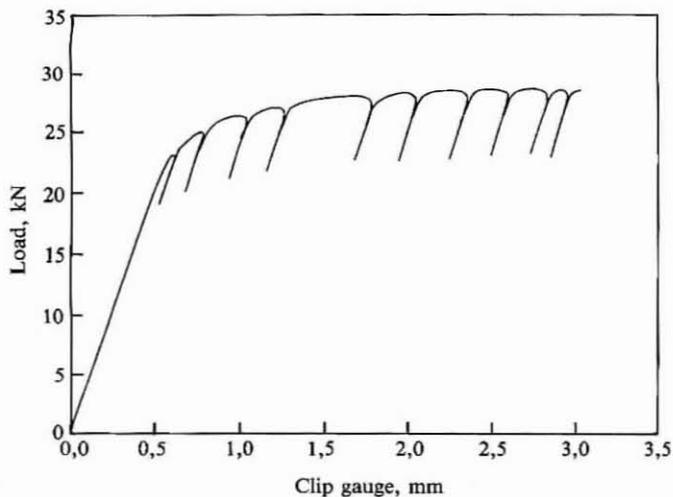
FIGURE 8. Graph of load versus clip-gauge displacement obtained during a J-integral fracture-toughness test of 3CR12. The load reversals result from the unloading compliance technique used for the measurement of crack length

The tendency of 3CR12 to delaminate also causes some experimental difficulties when attempts are made to determine its fracture toughness. Since the material is ductile, the appropriate fracture-toughness test is either the COD test<sup>19</sup> or the J-integral test<sup>20</sup>. The latter test requires that the energy absorbed be plotted against the variation in the length of the crack. The length of the crack in a sample that is in the process of delaminating is, however, an indeterminate quantity. Figure 8 shows a trace of load versus clip-gauge displacement in a specimen of 3CR12 that was loaded in a J-integral test. The load-clip trace *appears* to show that extensive yielding and tearing have taken place. However, examination of the actual specimen after heat tinting and cryogenic fracturing revealed (Figure 9) that no extension of the pre-fatigue crack had taken place, although there was extensive delamination (arrowed).

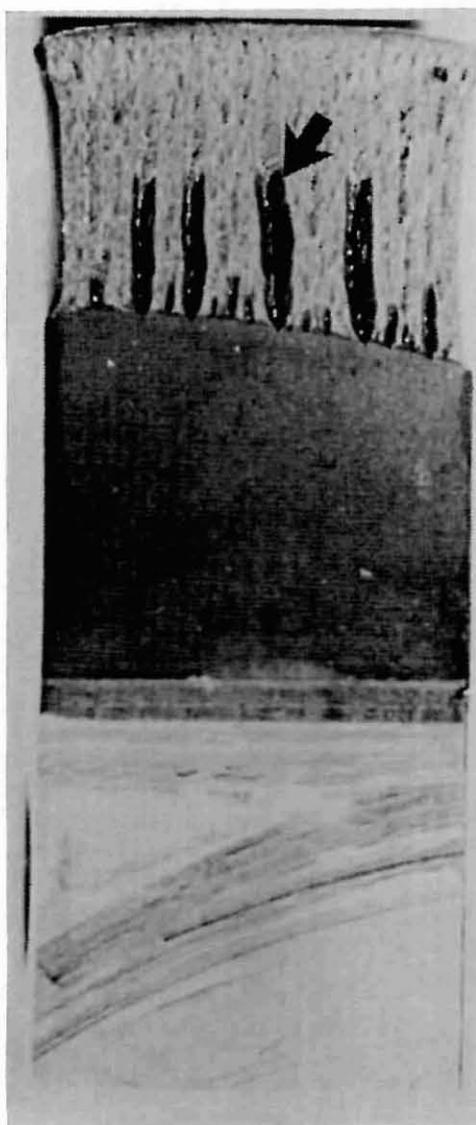
FIGURE 9. The fracture-toughness specimen shown in Figure 8 after heat-tinting and cryogenic fracture. Extensive delamination has taken place (arrowed)

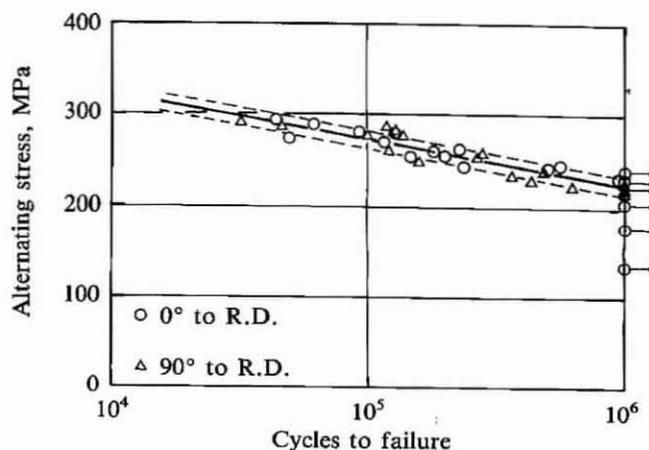
FIGURE 10. S-N diagram for the fatigue behaviour of 3CR12 specimens in air at 25 °C for specimens at 0 and 90° to the rolling direction

In the present work, it was found that the fatigue endurance of the as-received material did not vary dramatically between the 0, 45, and 90° specimens, although there was an indication that the life of the 45° specimens *may* have been slightly shorter than the others. The fatigue lives of the heat-treated specimens lay within the scatter band of the fatigue lives of the as-received specimens, and there is no justification at this stage for supposing that any difference exists between them for this particular type of test. The results for specimens in the 0 and 90° orientations are shown in the S-N diagram of Figure 10. Overall, the results are similar to those expected for normal structural steels, confirming the findings of previous investigators<sup>10</sup>.

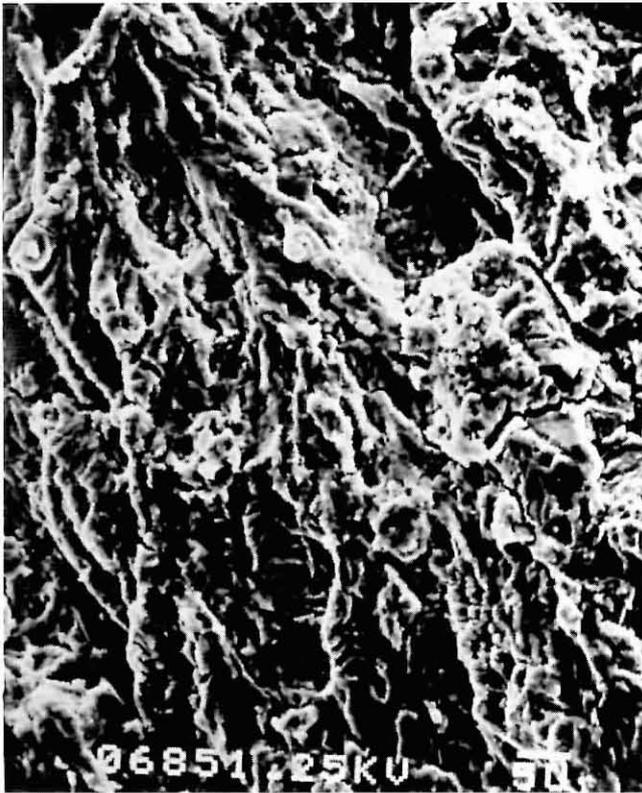
FIGURE 11. Surface of a fatigue crack in as-received 3CR12, showing striations and secondary cracking

Despite the similarity in their fatigue lives, the as-received and the heat-treated specimens exhibited rather different fatigue-cracking mechanisms. The cracks in as-received specimens were propagated by the formation of ductile striations accompanied by delamination at right-angles to the crack. A typical region is shown in Figure 11, and contains secondary cracking and patches of striations. Figure 12 shows the delamination that occurred *ahead* of a fatigue crack propagating in a compact-tension specimen. This is indicated by the fact that the crack front has bowed at the delaminations. The alternating stress intensity over the region of cracking shown was about  $60 \text{ MPa}\sqrt{\text{m}}$ .

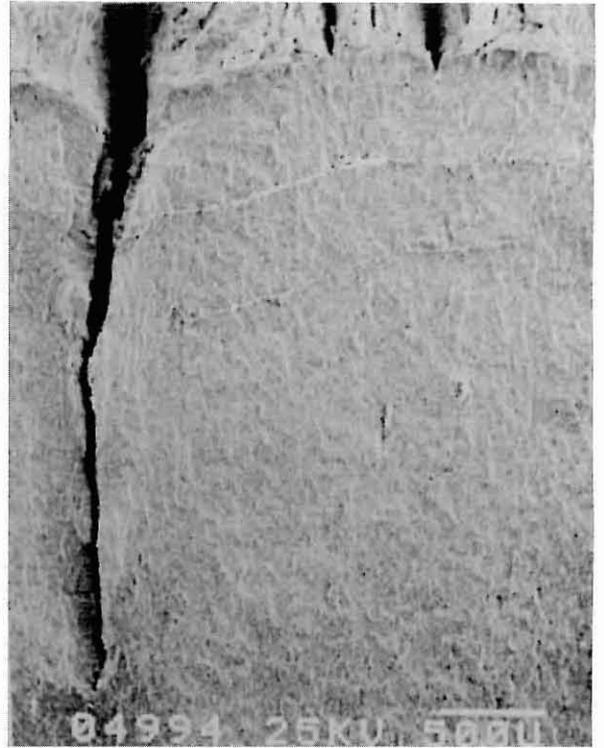
FIGURE 12. Low-magnification view of an S-N specimen of as-received 3CR12, showing that the final fracture was associated with extensive delamination

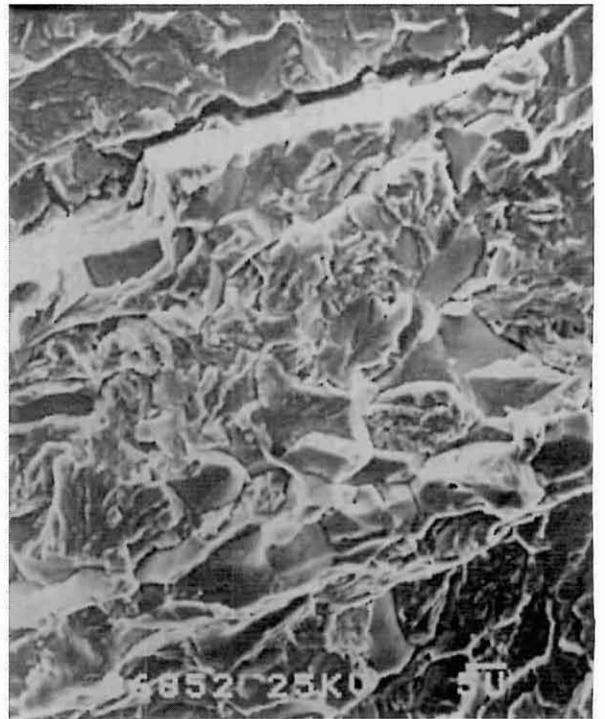
FIGURE 13. Surface of a fatigue crack in a sample of heat-treated 3CR12. The crack was propagated by a mixture of intergranular fracture and quasi-cleavage

The surfaces of the cracks in the heat-treated material were rather different, and showed that cracking occurred by intergranular fracture around the ferrite grains and quasi-cleavage through the martensite (Figure 13). Delamination

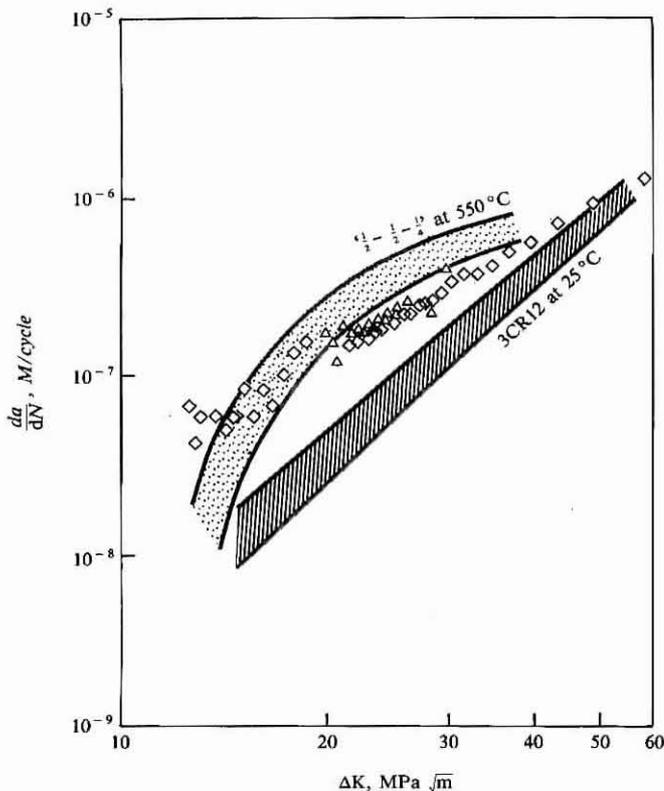
FIGURE 14. Rate of fatigue-crack propagation in 3CR12 at 550 °C and 1 Hz. The rate of fatigue-crack propagation in 3CR12 at room temperature and that of the alloy 1/2-1/2-1/4 at 550 °C are shown as scatter bands

The propagation rate of fatigue cracks at 550 °C is shown in Figure 14. The diagram also shows a scatter band encompassing the reported rates of crack growth in 3CR12 at room temperature, as well as a curve showing the behaviour measured for the alloy Fe-0,5% Cr-0,5% Mo-0,25% V (frequently known as 1/2-1/2-1/4). It is evident that the rate of fatigue-crack propagation in 3CR12 at 550 °C is comparable with that of the latter alloy, which is frequently specified for application in the steam lines of power stations.

The rate of fatigue-crack propagation in 3CR12 is about five times greater at 550 °C than at room temperature at  $\Delta K$  values of about 20 MPa $\sqrt{m}$ . The difference between the rates of fatigue-crack growth at 550 °C and room temperature decreases as  $\Delta K$  rises, and the rate of growth at 60 MPa $\sqrt{m}$  does not vary much over the temperature range 25 to 600 °C. These results indicate that there is a time-dependent component to the propagation of fatigue cracks in
