RAPID REDESIGN AND RESTART OF THE VALE ONÇA PUMA NICKEL SMELTER

Sean Southall¹, Roberto Damasceno², Antonin Zemanek¹, Alexandre Griebeler¹, Glenn Stevens¹, Brett Emery¹, Jakob Janzen¹

ABSTRACT

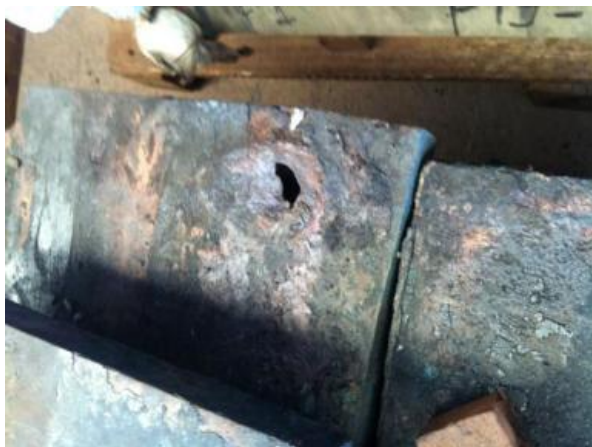
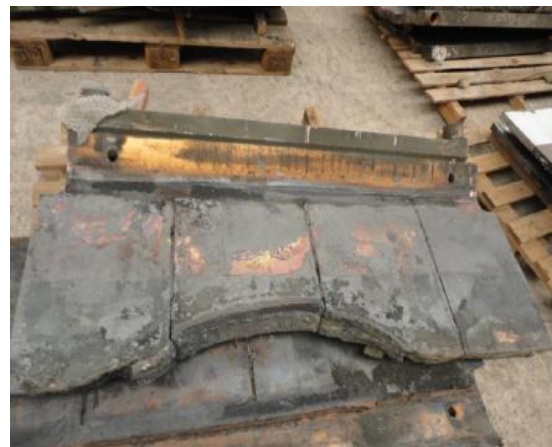
Figure 2: Damaged Coolers Removed from the Furnaces (Original Design by Others)

The existing coolers from both furnaces were carefully removed and inspected for reuse. One third of the coolers were found to have excessive corrosion, pitting, flaking of the chrome coating, and penciling which ruled them as unsalvageable, as shown in Figure 2. The poor condition of many of the coolers was unexpected due to their short operation duration. The reduced number of acceptable coolers required the cooler layout, and in turn the associated shell panels, to be quickly redesigned. The final design utilized new Hatch plate coolers in the high heat flux metal zone and a combination of new and reused coolers in the lower duty reserve slag capacity area.

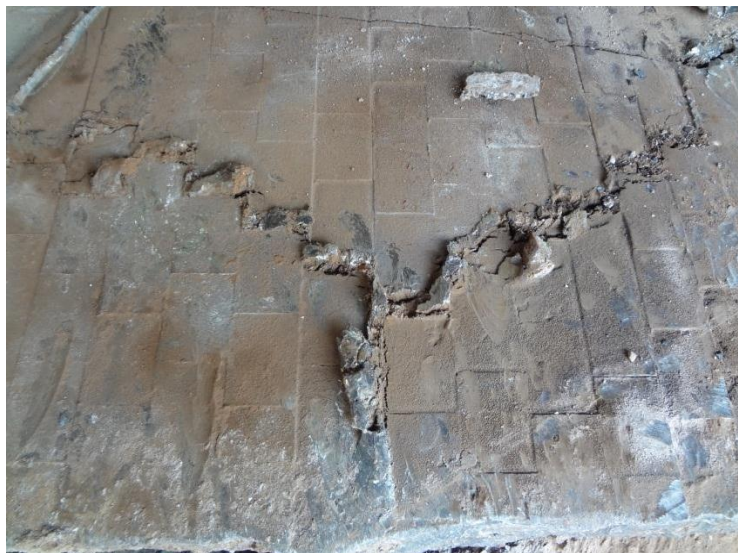
Figure 4: Onça Puma Hearth During Demolition

The original furnace design utilized a combination of a fixed frame design in the transverse direction and a more conventional sprung bound system in the longitudinal direction. A fixed frame design has the same limitations as a traditional round furnace; the system is unable to maintain tight brick joints during a cooling phase. The longitudinal binding system was not capable of maintaining brick joint tightness during cooldown which led to bath infiltration between the refractory bricks. The result was a highly infiltrated hearth as shown in Figure 4.

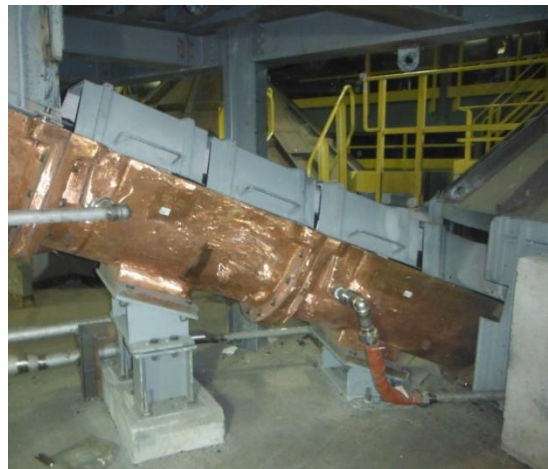
The launder profile was improved and a profile with a curved bottom and tapered sides implemented to minimize the wetted surface in contact with the molten slag flow. Implementation of these design changes has led to an observed reduction in formation of build-up on the launders. The build-up that does form, tends to be thinner and easier to break free of the launder surface when cleaning.

As a direct result of the design and operation improvements implemented, operators have reported that the launder cleaning operation now involves very little effort. This is proven by the time to clean the launders which is now less than 2 minutes which is reduced significantly from the cycle time of more than 60 minutes on the original furnace.
