Challenges and solutions in PGM furnace operation: high matte temperature and copper cooler corrosion

by A. Shaw*, L.P.v.S. de Villiers†, R.J. Hundermark†, J. Ndlovu†, L.R. Nelson†, B. Pieterse†, R. Sullivan*, N. Voermann*, C. Walker*, F. Stober*, and A.D. McKenzie‡

Synopsis

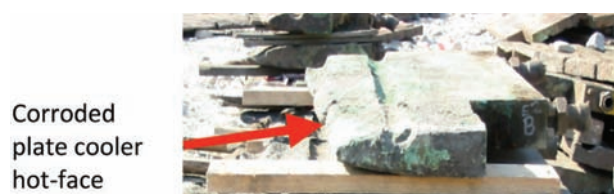
Figure 4—Severe upper plate cooler corrosion at Waterval Smelter. Note increased corrosion of upper plate cooler located in the furnace nearest the top of slag and concentrate interface

Corrosion is also not limited to waffle coolers. Given time, copper plate coolers in PGM furnaces are corroded to a short sharp edge (Figure 4), barely protruding into the furnace wall, and so reducing their cooling effect and upper wall stability. The corrosion is pervasive and continues to some extent throughout the furnace, not being limited to attack of copper, but also of basic magnesia-based refractories where magnesium sulphates (often resulting from sulphidation of

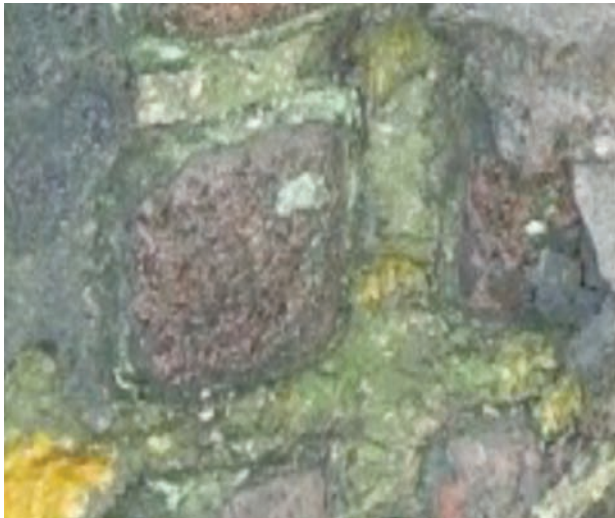
Figure 6—Typical corroded cooler – yellow elemental sulphur deposited on black copper sulfide corrosion product on copper. Grey covering is frozen slag accretion

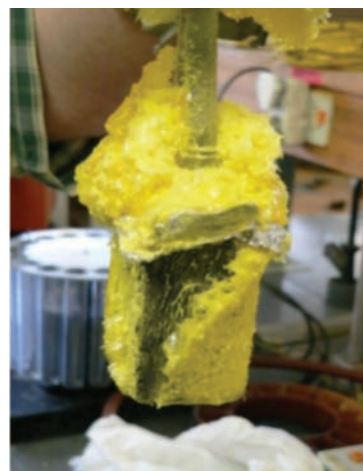
Figure 12—Water-cooled copper specimen coated with sulphur after testing

copper was indeed feasible even at a temperature as low as 25°C (0.2 mm over 14 days or 5.2 mm/a). As the copper temperature is raised to 90°C the corrosion rate increases to 16 mm/a. At a copper temperature of 125°C, the rate is

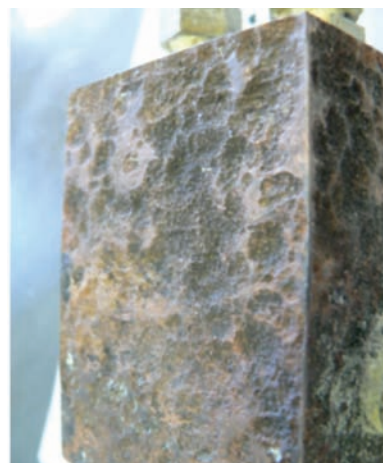
Figure 13—Copper corrosion at low 50°C temperature after only 5 days' exposure

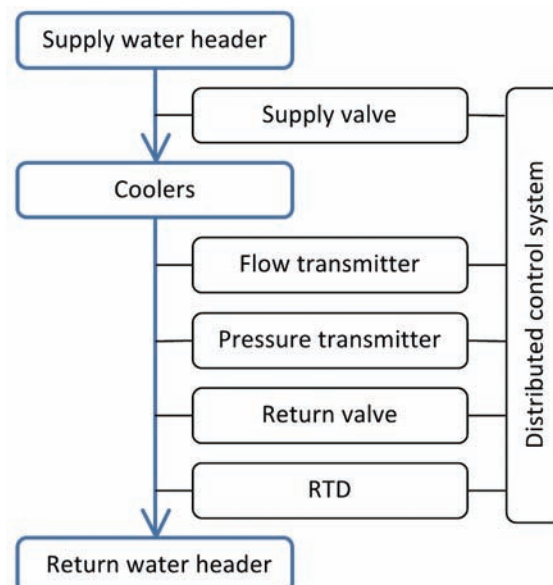
Figure 15—Schematic showing the automated pressure testing system components

An automatic water leak detection system was developed and installed on the cooler water circuits to detect pinhole leaks based on pressure (Figure 15). This system momentarily stops the flow of water on a circuit using valves at the inlet and outlet. A pressure transmitter then checks for a decrease in static pressure. The system is very sensitive, and leaks as small as a few drops per minute can be detected (Figure 16). Once detected, a leaking water circuit can be isolated because the cooler is designed with dual redundant water-cooling circuits. Consequently, a faulty cooler or piping can be replaced without further risk of refractory hydration or an explosion. This is not a continuous leak detection method, but it is automatically run at regular intervals selectable to as little as 4-hourly. This is the most direct and valuable monitoring system of the cooler condition available to operators.

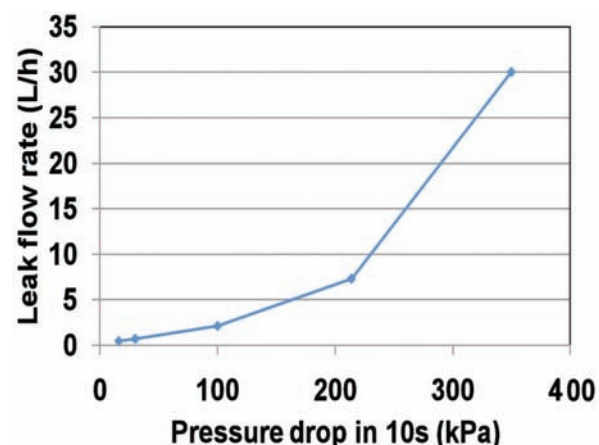
Figure 16—Leak simulation testing results indicating system sensitivity (Mahape, 2005)

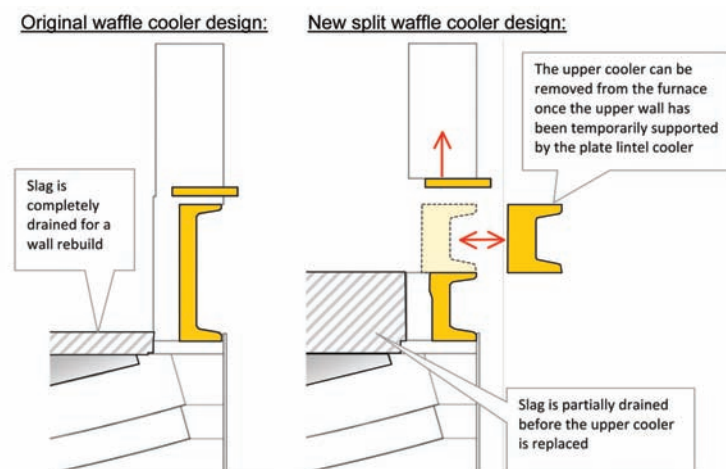
Figure 17—Diagram showing the original waffle coolers and the redesigned split coolers, which can be replaced quickly from outside a 'hot' furnace

It was possible to reduce the replacement cost of the waffle coolers by splitting them horizontally into upper and lower blocks because the most severe corrosion occurred mainly in the upper portion of the waffle coolers near the slag-concentrate interface (Figure 17). By doing this, the corrosion-prone upper waffle coolers could be replaced independently of the lower waffle coolers. One advantage of this arrangement is that the slag bath needs to be only

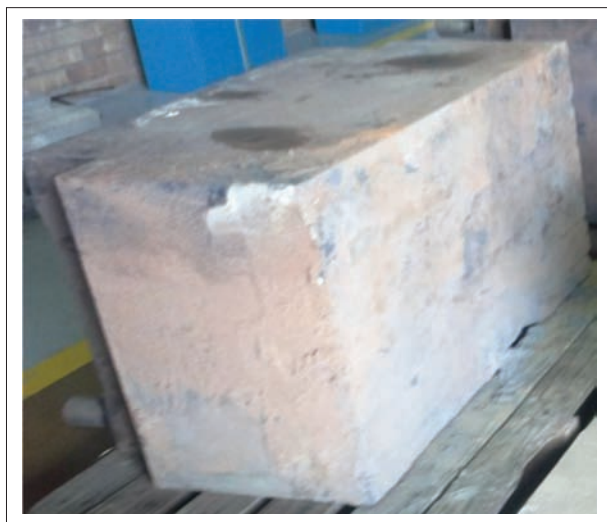
Figure 18—Upper cooler copper and graphite in pristine condition after being installed in the furnace for 12 months

Two consecutive planned annual inspections of the latest generation of graphite-protected copper coolers revealed the graphite to be in near pristine condition after 12 months' service. Given that the life of the original coolers was approximately one year, these results are very positive.
