NEW REFRACTORY LINING DIRECTION AT JINDAL STAINLESS FeCr #1 AND #2 FURNACES

C. Coetzee¹, P.H. Lamont², P.L Duncanson³, P. Sylven⁴

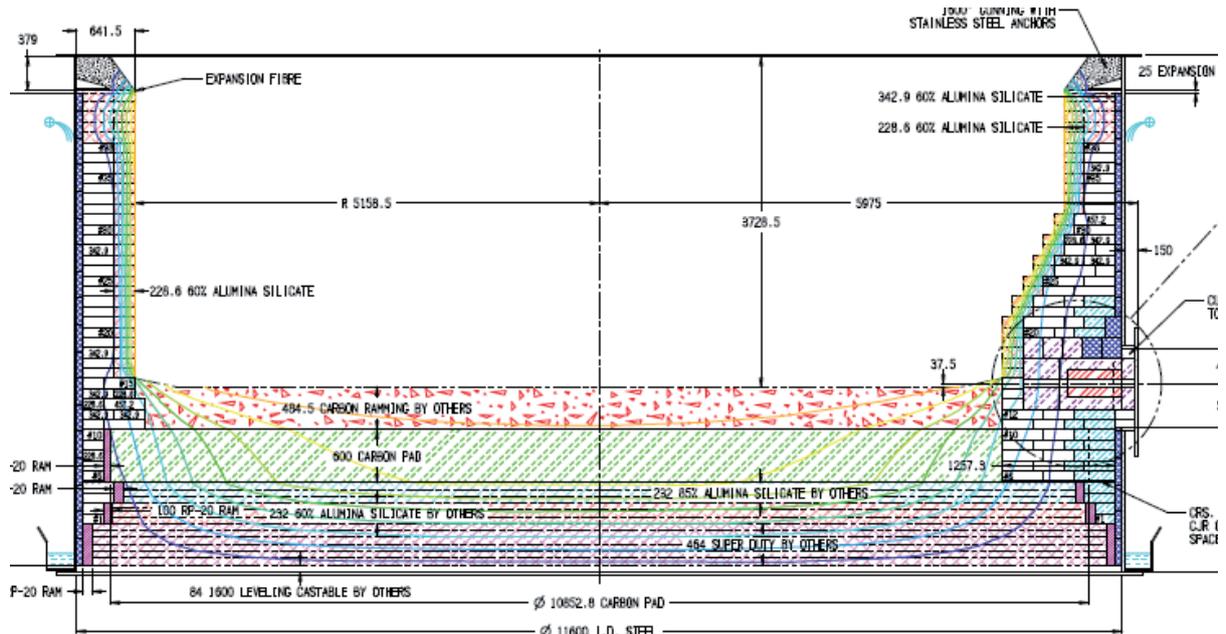
Figure 1: GrafTech ChillKote™ lining Jindal #2 (similar to Jindal #1)

Both Jindal #1 and #2 are 11.6m diameter FeCr furnaces installed with GrafTech ChillKote™ linings [1]. The Jindal #1 furnace is a 60 MVA SMS Demag furnace with a daily hot metal production of approximately 200 tons FeCr. This furnace was commissioned during March 2008 and has been showing exceptional operational and lining performance. The furnace was installed incorporating the GrafTech ChillKote™ lining technology. This technology has significantly improved the expected lifetime of this furnace after the failure of the big block lining before the performance guarantee period was reached. No significant wear could be seen. The Jindal #2 FeCr furnace was also rebuilt with this technology during December 2008. Figure 1 shows the current freeze lining configuration used on the #1 and #2 furnaces. Notable is that both these furnaces were originally installed incorporating conventional “big block” carbon technology. Unfortunately, this lining technology failed before the furnace guarantee period was met. Previous repairs were attempted as well prior to the complete technology change.

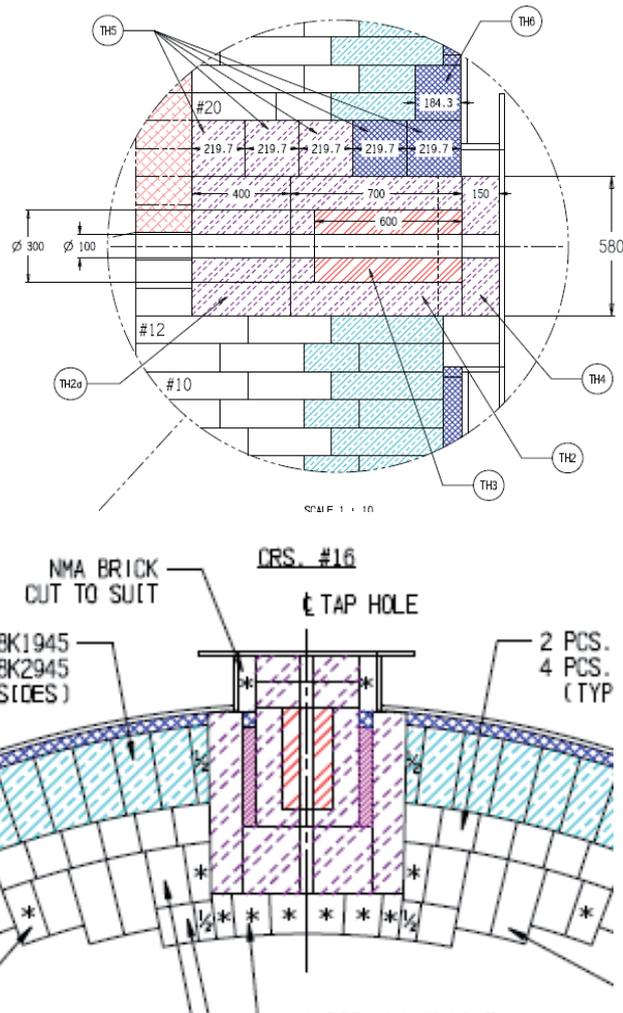
Figure 2: GrafTech improved tap hole configuration

Figure 2 shows the new and improved GrafTech tap hole configuration that was installed for the first time at Jindal #1. Having the two carbon side blocks using GrafTech's Smart Ram® RP20 ramming paste joints will enable fast and easy changing of the carbon front block and graphite sleeve, if needed. The ramming will also form the joint between the tap hole abutment and the physical tap block. When a front block or sleeve requires changing, only the applicable components will be broken out. No damage will be done to the remainder of the abutment as was seen at previous tap hole repairs on large SAFs around the world.

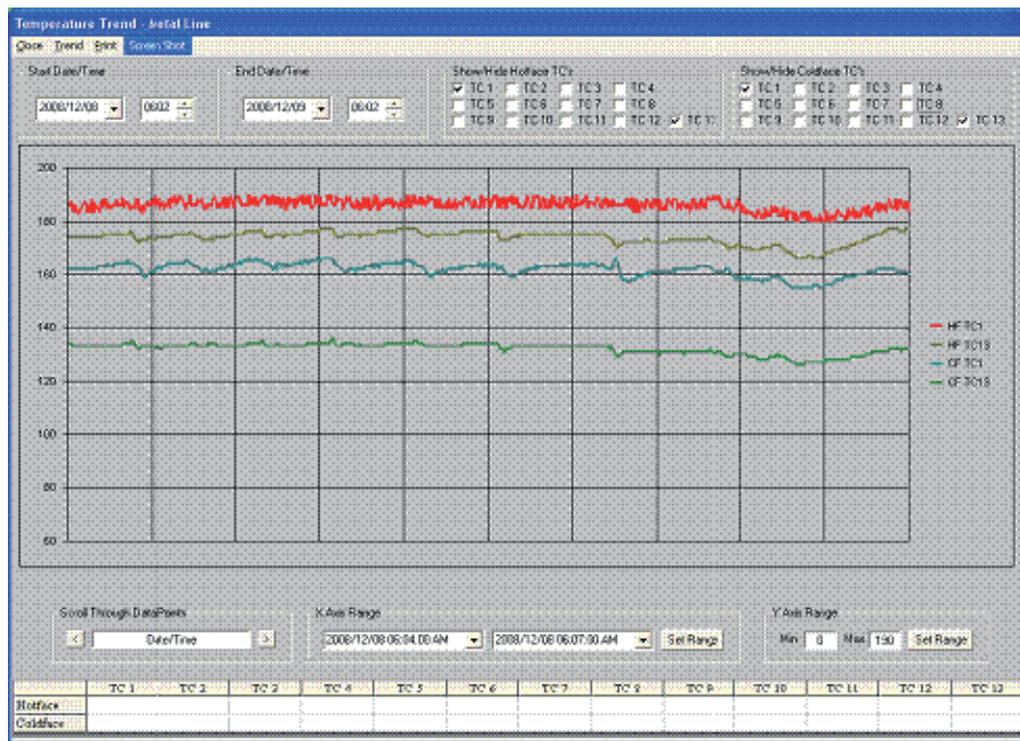
Figure 3: Trending of thermocouples 1 and 13 around tap hole varying between 120 – 200 degrees Celsius

Dual type K thermocouples were installed 300mm and 150mm from the inside of the shell on the metal, slag and freeboard areas. Since start-up, the furnace has shown little significant increase in temperature due to lining wear. Figure 3 shows the trending of thermocouple 1 and 13 directly next to the tap hole. The trending looks very favorable as both the inner and outer thermocouples follow the same trend. Temperatures increased to just below 200 deg C during tapping but decreased again after tapping. Typically the outer couple temperatures should be more in the range of 300- 400 deg C. Thus we feel confident that the tap hole area is still in a very good condition. Although some lancing has been employed over the past year, we don't see any need to be concerned at this stage. However, more disciplined lancing procedures are recommended in order to extend this and any other tap hole life in submerged arc furnaces. It is advisable that the following four variables be checked regularly:

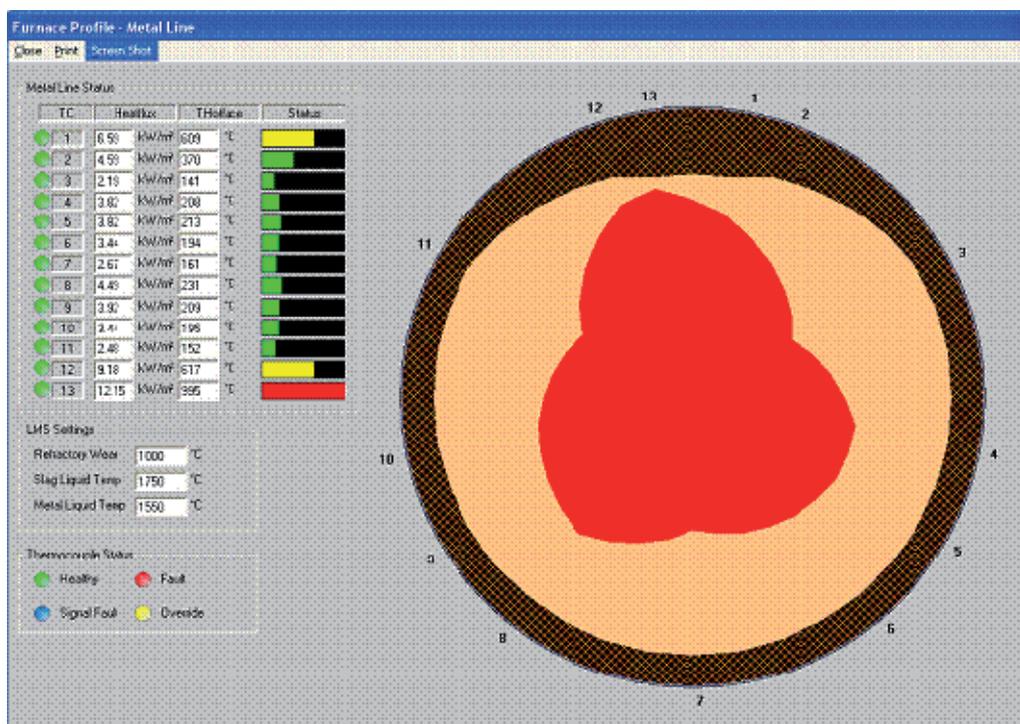
Figure 4: Clover profile at Metal line

In a GrafTech refractory lining, the hot face temperature of the carbon bricks should always be less than 600 deg C to prevent oxidation of the carbon brick. Figure 6 shows the clover profile of the lining. Higher temperatures are seen around the tap hole and across the electrodes. This is expected in any submerged arc furnace, and the heat flux in these areas is also higher than between the electrodes. Higher temperatures can also be attributed to the loss of protective skull, electrode lengths and breaks and also power input. Spikes in temperature should be carefully analyzed. The most important aspect of lining management is that spikes should return to normal and trending should be steady over a period of time. Any increase over time in all thermocouples temperatures should be taken very seriously and the reason(s) should be identified and rectified.

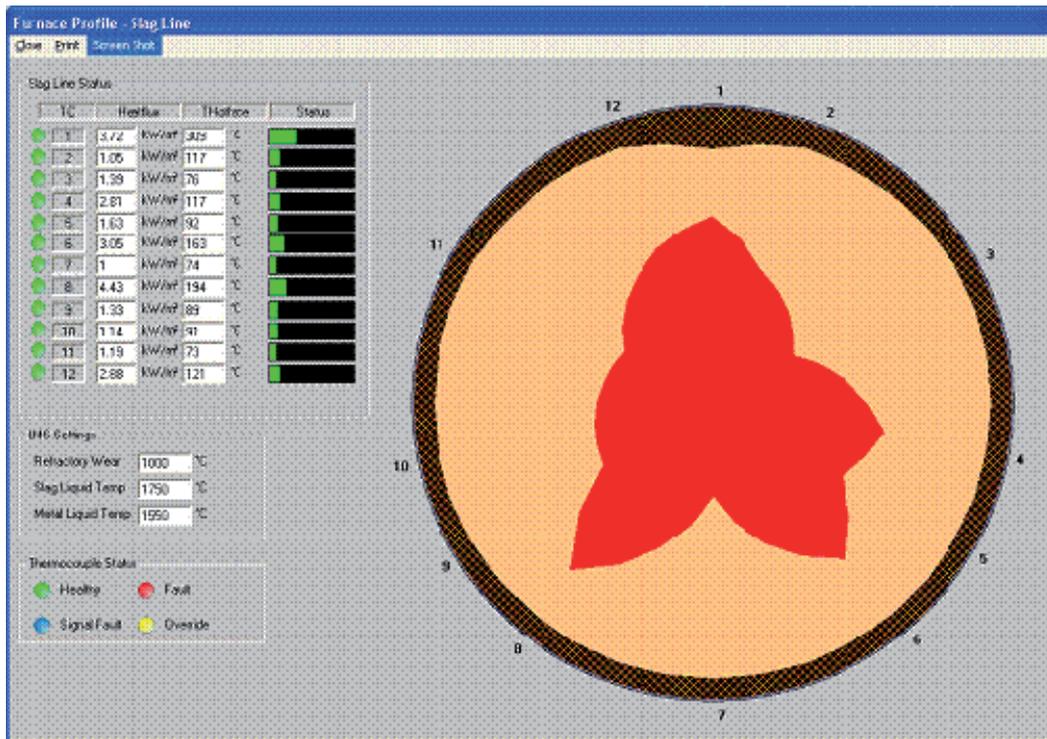
Figure 5: Clover profile at Slag Line

Figure 5 shows the clover position at the slag line. It was noted that this profile is significantly different than the metal line clover profile. Thermocouples #8 and #6 across electrodes at back, in particular, showed temperatures higher than the rest of the thermocouples on the slag line. In such a case, the reason may be electrodes running at a higher position in the furnace, or as discussed above, loss of skull. The temperatures are still very low compared to typical hot face temperatures on similar FeCr furnaces worldwide, thus no reason for further investigation/preventive actions at this stage. This furnace is currently running at approximately 32MW input, which is at the limit of the furnace design capacity. Any MW input higher than this will also result in lining temperatures increasing in the sidewalls, especially across electrodes.

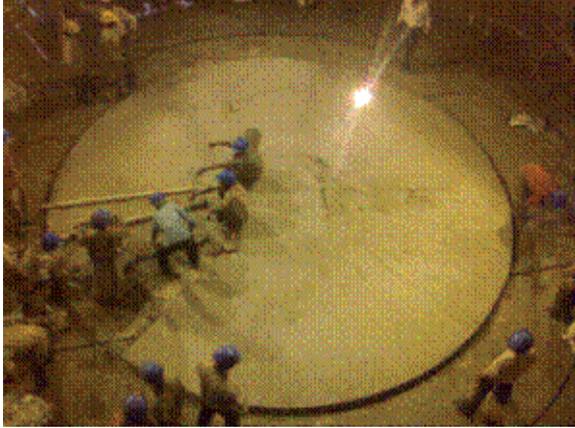
Figure 6: Pouring of Levelling castable

1. **Check the level of the shell plate at bottom and install a levelling castable:** Before any brickwork could commence, IRCI, as well as plant personnel, conducted a proper steel inspection. The bottom plate was not level, but this could be rectified by means of a ceramic levelling castable. The steel shell was not completely circular with numerous flat spots and all welding joints had to be grinded flush. Figure 6 indicates pouring of the levelling castable.

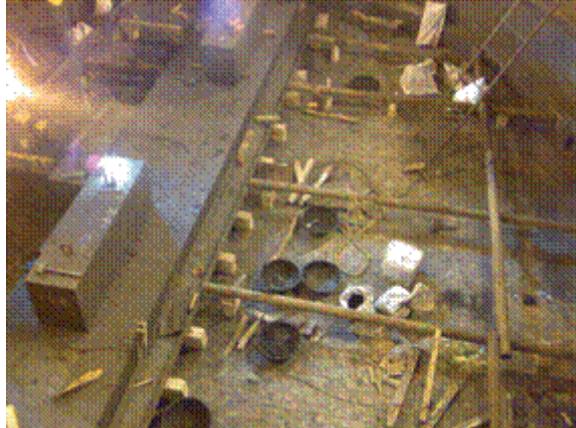
Figure 7: GradeD™ carbon block in hearth showing proper jacking by means of jacks and wooden poles

6. **Proper Installation of GradeD™ Carbon Blocks:** Floor blocks were installed with extreme care so as not to damage any of them. Blocks entered the furnace on rollers and were handled inside the furnace by means of crawl beam and hoist. GrafTech requires a 1.7mm cement joint between the carbon blocks. This ensures that good thermal conductivity can be obtained between all the blocks. To ensure this good contact, all blocks were jacked by means of wooden poles and steel beams as seen in figure 7.

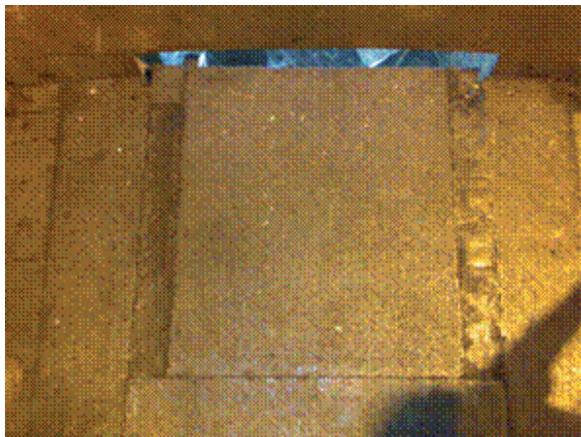
Figure 8: New and improved GrafTech tap hole configuration

9. **Tap hole abutment installed according to GrafTech improved tap hole configuration:** Instead of only installing one carbon tap block, GrafTech has improved the tap hole configuration to improve lifetime and assist with changing of tap block during repairs. The new and improved configuration incorporates 2 carbon blocks instead of one solid block with a Smart Ram® RP20 ramming paste joints between two carbon side blocks. The RP20 will be broken out when changing a block, and the side blocks serve to protect the bricks in the abutment when break-out occurs. Instead, only the front block is broken out and replaced. This will also ensure shorter downtime while doing tap hole maintenance and repair. The new

and improved configuration can be seen from above in figure 8. Figure 9 shows the tap block and surrounding bricks as seen from outside of the furnace.

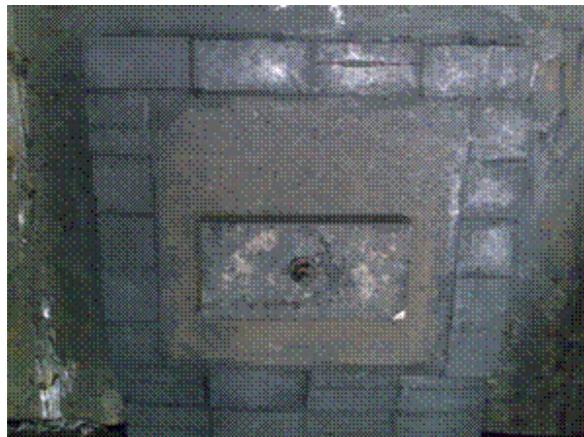
Figure 9: Tap block and surrounding bricks inside steel flange as see from outside of furnace
